Shibden Collapsed Wall Section KELL LANE, HALIFAX

Client
Calderdale Council

Consulting Engineers
Mouchel

Solution
5 Rotary Boreholes

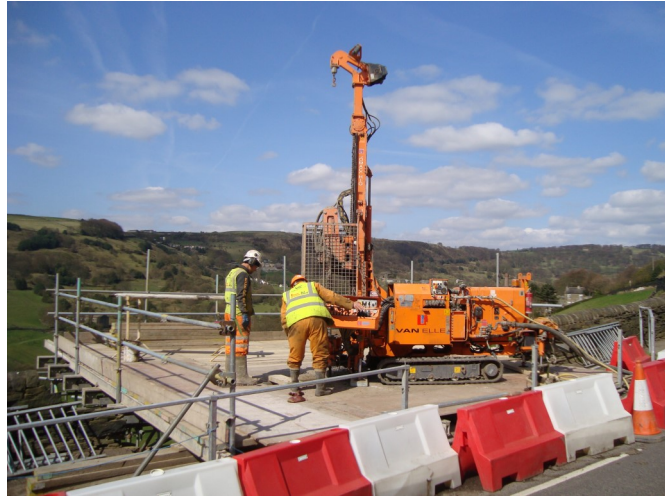
As the wall was right next to the carriageway and to avoid a full road closure, a temporary platform was built on which to stand the rig. Traffic management was also used to minimise the impact to the public and to prevent accidents being caused as a result of this work.

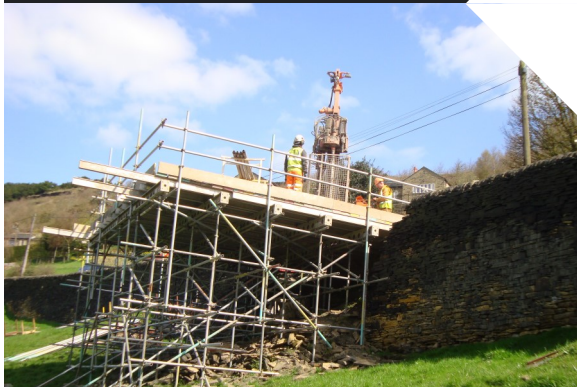
Across the 5 locations, the boreholes were terminated at depths of between 12.5m and 14.0m bgl. The ground conditions experienced were similar and comprised of made ground down to 0.6m, yellow clay to 2.2m, weathered mudstone to 4.1m, shale to 8.7m, coal to 8.85m and mudstone beneath that to an undetermined depth.
